THE MALDEN SURVEY

A REPORT ON THE CHURCH PLANTS OF
A TYPICAL CITY, SHOWING THE USE
OF THE INTERCHURCH WORLD MOVE-
MENT SCORE CARD AND STANDARDS
FOR RATING CITY CHURCH PLANTS

Copyright 1920 by the
Interchurch World Movement
of North America

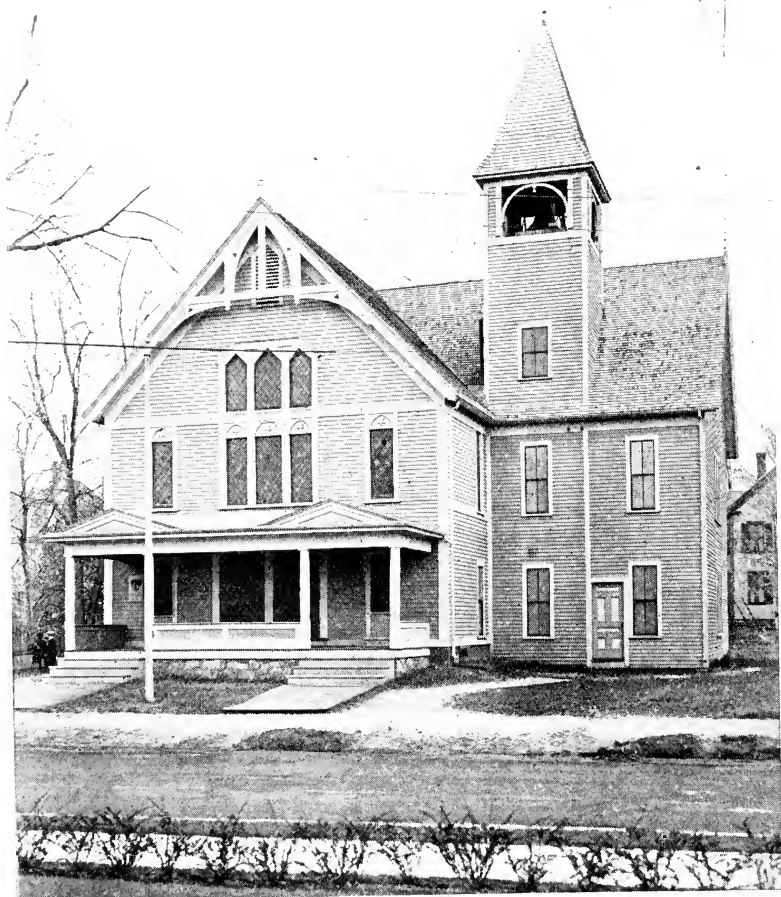
ILLUSTRATION 13. LINDEN CONGREGATIONAL CHURCH

The site of this church is too small for anything but the building to stand upon and is also poorly drained. The present building serves as a handicap, not only because of the meager number of rooms available but also because of their poor equipment. The main auditorium being on the second floor with inadequate means of access is a source of both inconvenience and danger, even though it makes possible a first or ground floor without any excavation for a basement.

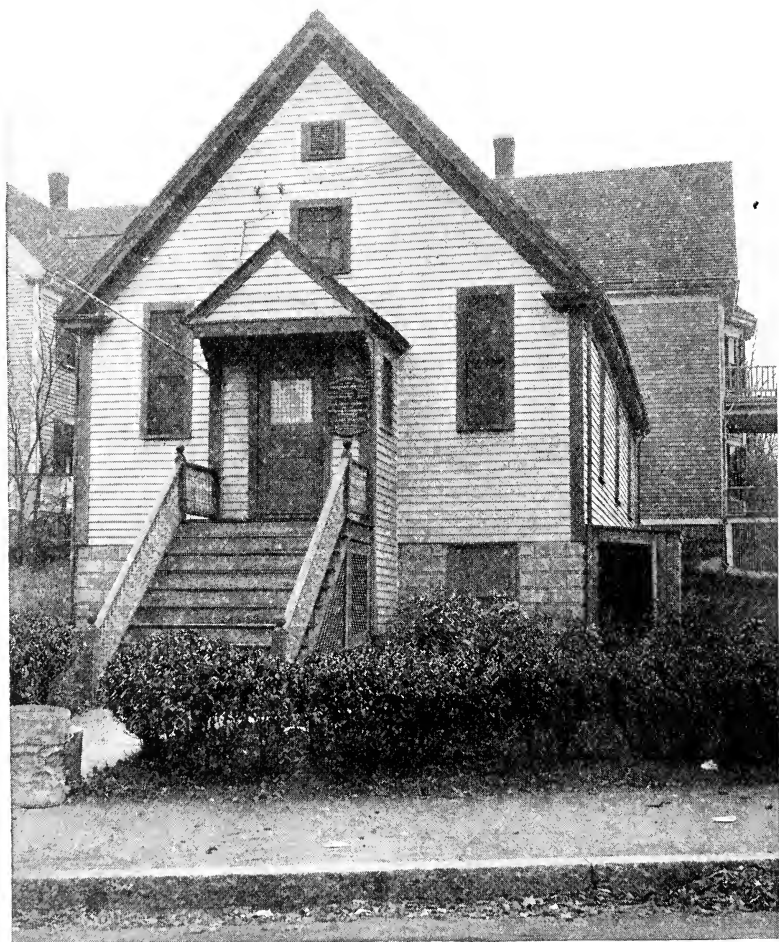
ILLUSTRATION 17. UNION BAPTIST CHURCH

About half of the score on this building has been allotted to the site. There is little else about this plant that has anything to commend it. It represents very little achievement on the part of any community group and should be replaced at the earliest moment by a standard plant.

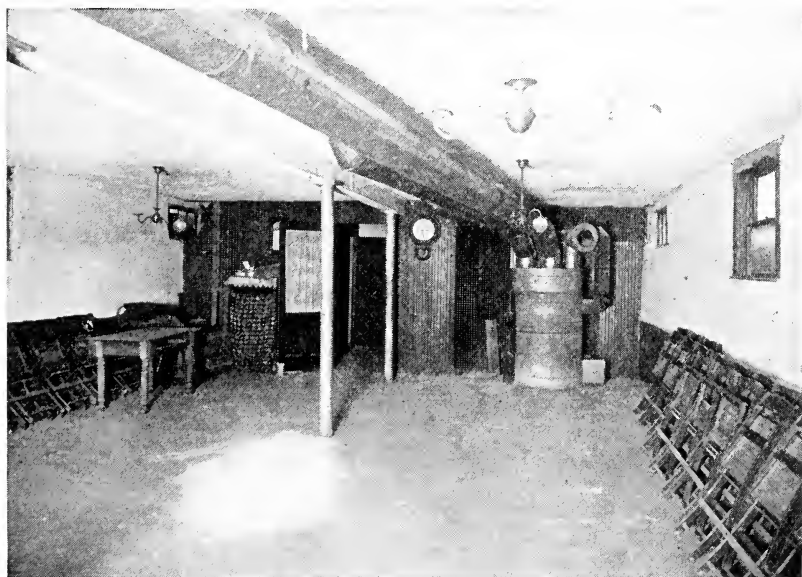
ILLUSTRATION 18. BASEMENT OF UNION BAPTIST CHURCH

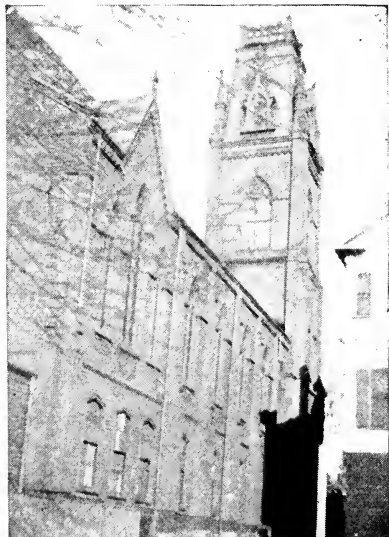
ILLUSTRATION 21. SIDE VIEW OF FIRST CONGREGATIONAL CHURCH SHOWING HOW ADJOINING BUILDING SHADOWS A CLASS ROOM

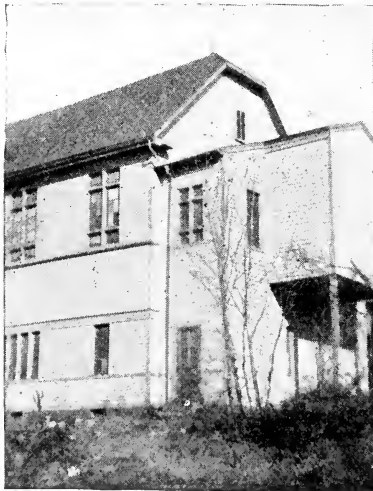
ILLUSTRATION 23. THE POORLY PLANNED MAPLEWOOD CONGREGATIONAL CHURCH ON ILL-KEPT GROUNDS

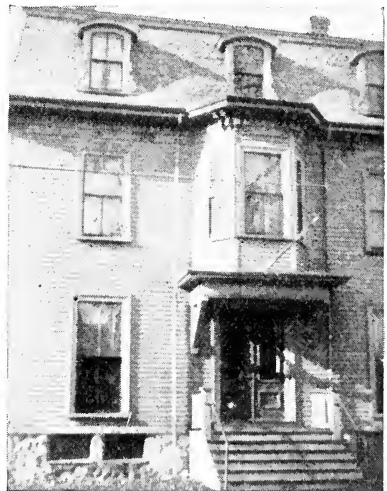
ILLUSTRATION 24. UNATTRACTIVE AND INADEQUATE TEMPORARY HOUSING FOR ST. PAUL'S SUNDAY SCHOOL ATTENDANTS

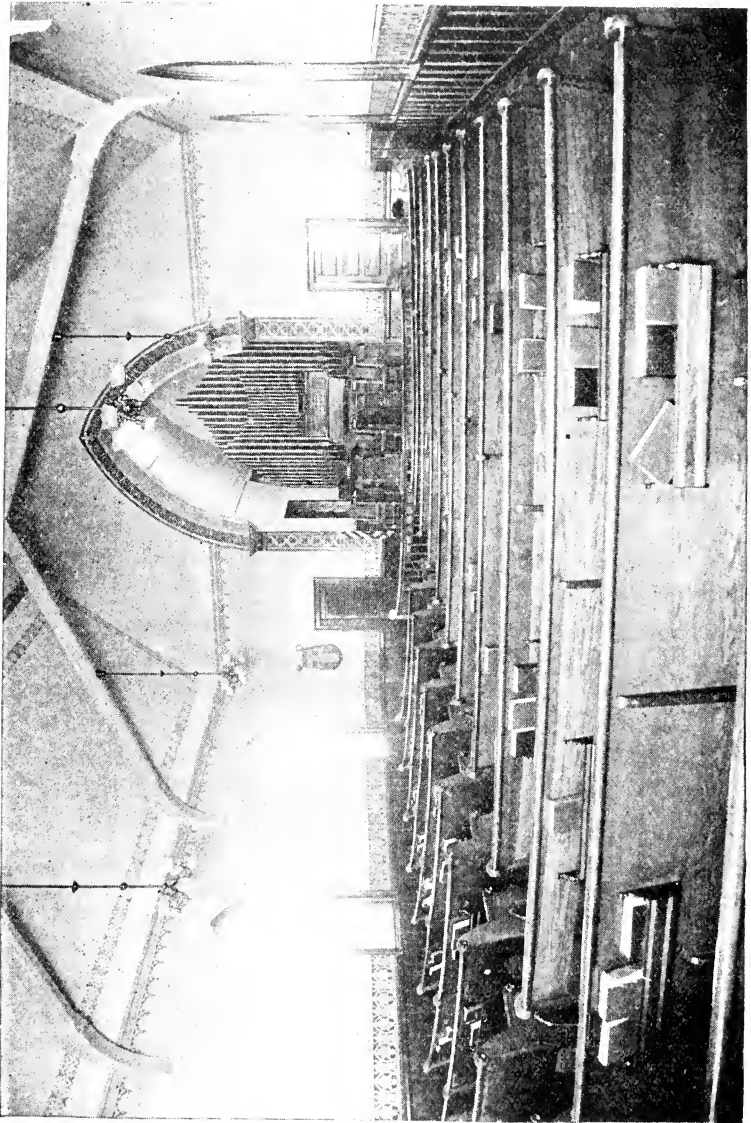
ILLUSTRATION 32. THE SECOND STORY AUDITORIUM, MAPLEWOOD METHODIST CHURCH, THE CHIEF EXIT FROM WHICH IS SHOWN IN ILLUSTRATION 34. A SECOND NARROW STAIRWAY, WHICH IS ALMOST UNUSABLE, IS AT THE RIGHT OF THE ORGAN

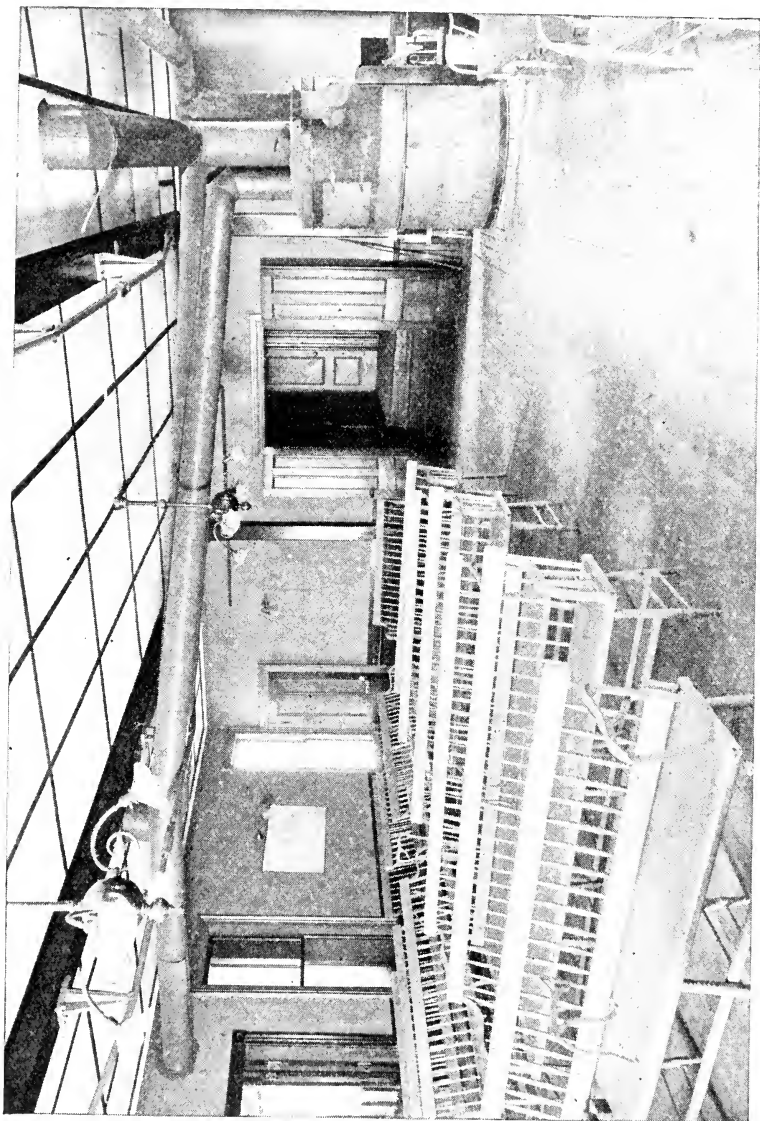
ILLUSTRATION 35. SHOWING THE IMPROPERLY PLANNED EXIT, THE UNSATISFACTORY SEATING ARRANGEMENTS, POOR LIGHTING AND INADEQUATE FURNISHINGS OF THE FIRST FLOOR SUNDAY SCHOOL ASSEMBLY ROOM OF THE LINDEN CONGREGATIONAL CHURCH

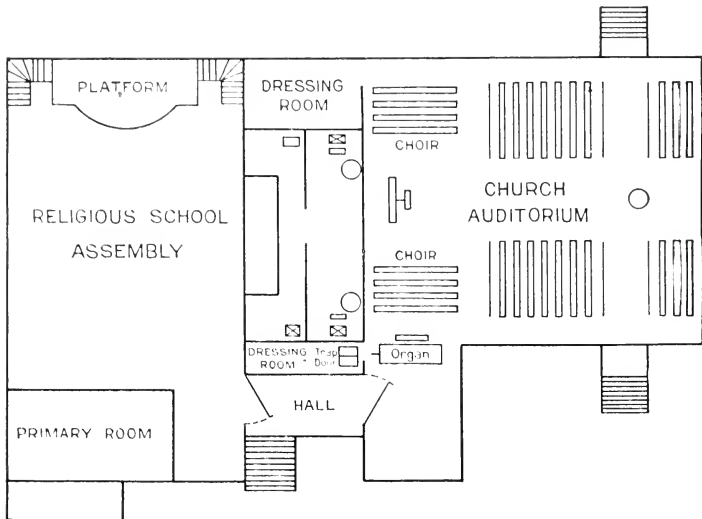
ILLUSTRATION 38. SHOWING INCONVENIENT ARRANGEMENT OF ROOMS AND DIFFICULTY OF PASSING AROUND ORGAN TO GET FROM SCHOOL ROOMS TO AUDITORIUM OF ST. LUKE'S EPISCOPAL CHURCH

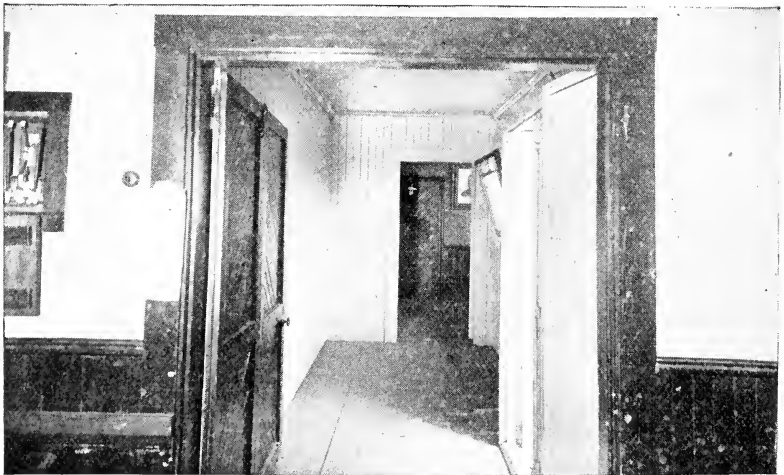
ILLUSTRATION 39. INADEQUATE FOYER AND CONNECTION BETWEEN RELIGIOUS EDUCATION ROOM AND AUDITORIUM IN ST. LUKE'S EPISCOPAL CHURCH

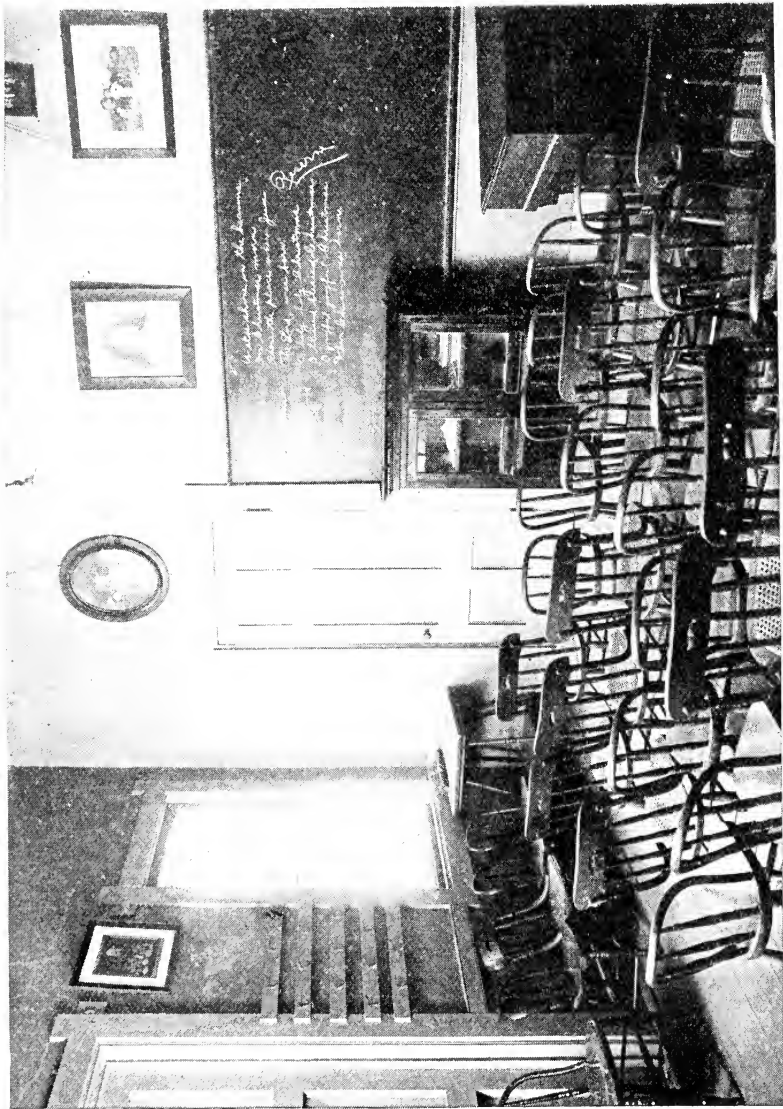
ILLUSTRATION 40. A PRIMARY CLASS ROOM, MAPLEWOOD CONGREGATIONAL CHURCH WITH INADEQUATE NATURAL AND ARTIFICIAL LIGHT. PICTURES TOO HIGH. EQUIPMENT MEAGER AND UNATTRACTIVE

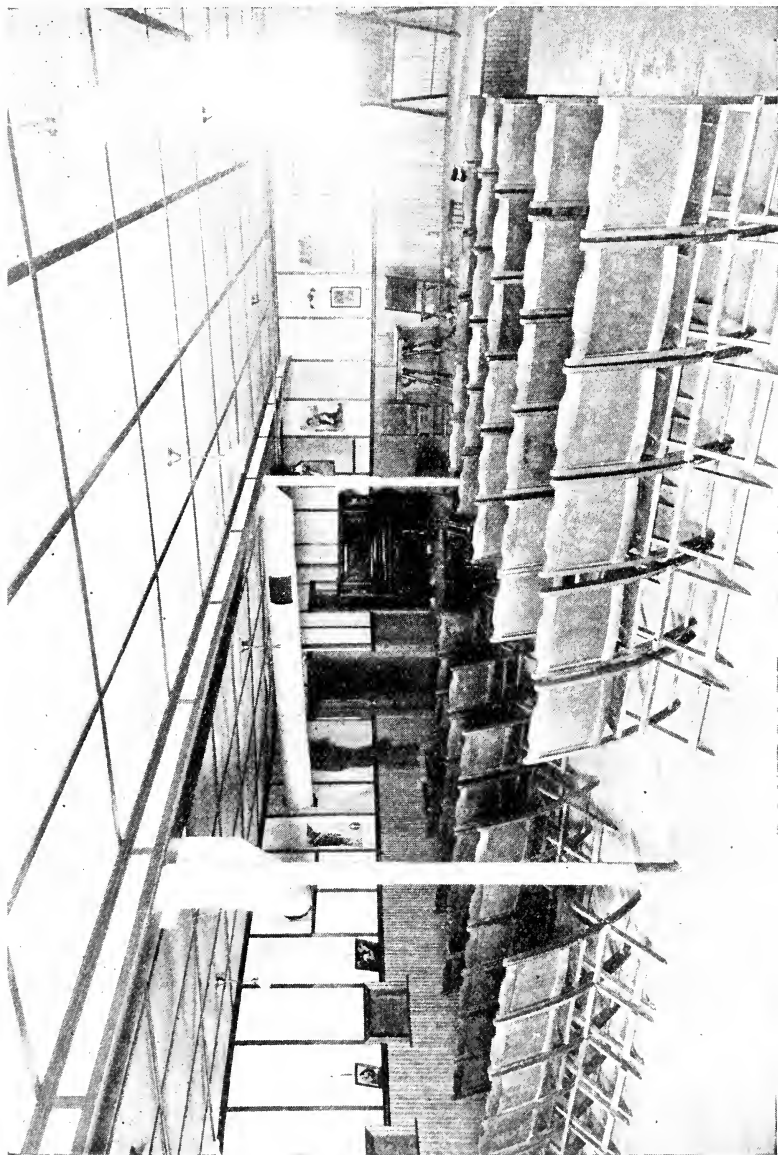
ILLUSTRATION 42. THE SUNDAY SCHOOL ROOM, LINDEN METHODIST CHURCH. COMPOSITION BOARD WALLS, CEMENT FLOOR, THE SECONDARY HEATING SCHEME AND THE POOR NATURAL LIGHTING CAUSE THIS BASEMENT ROOM TO RATE LOW

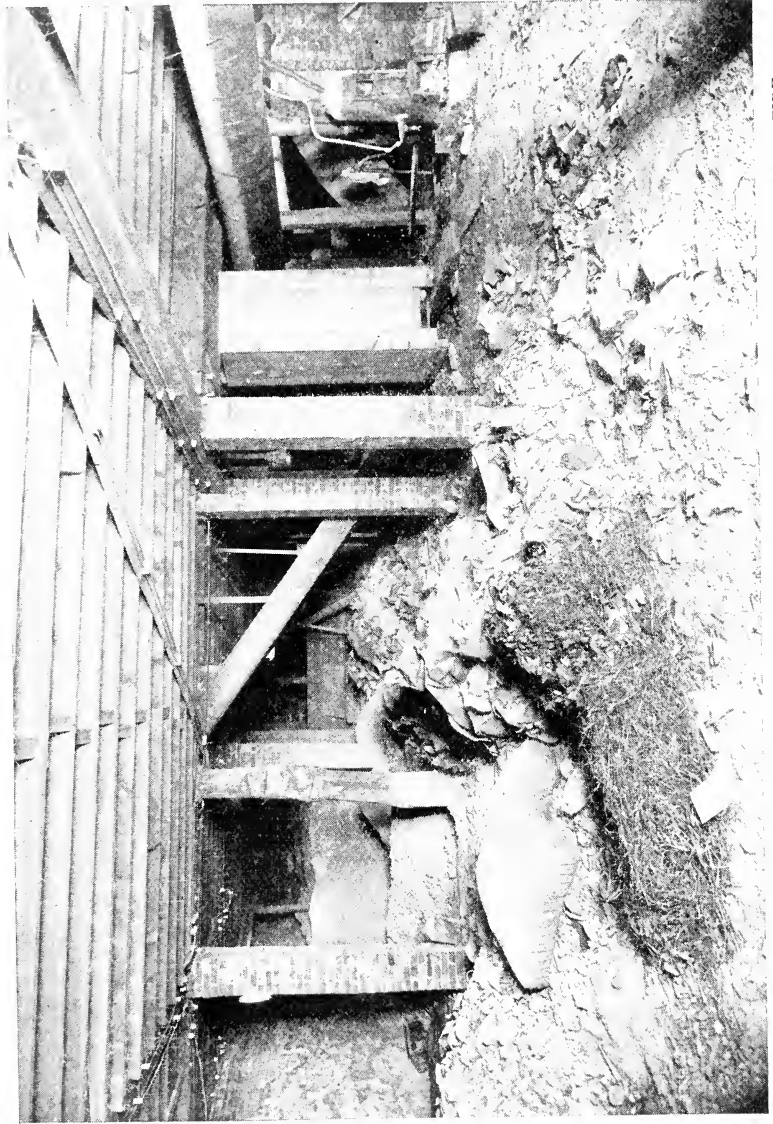
ILLUSTRATION 43. THIS BASEMENT IN THE MAPLEWOOD BAPTIST CHURCH PRESENTS MANY FIRE HAZARDS WHICH SHOULD NOT BE TOLERATED IN ANY PUBLIC BUILDING

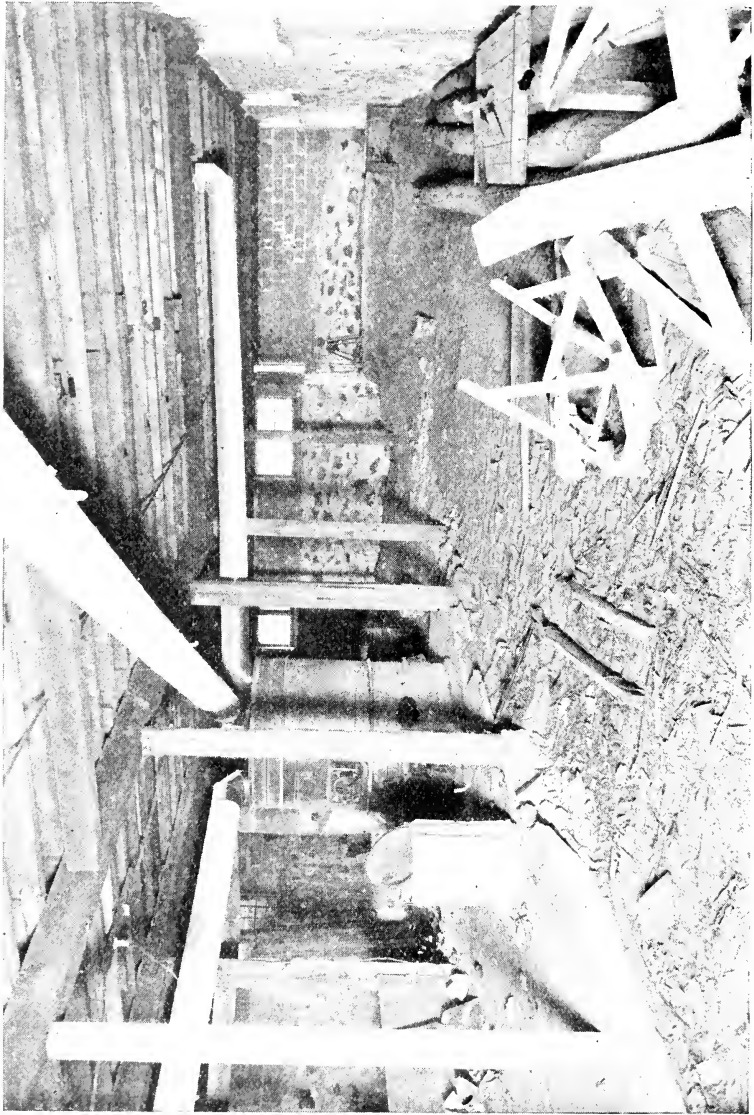
ILLUSTRATION 44. THE BASEMENT IN ST. LUKE'S EPISCOPAL CHURCH, THE LIGHTING AND ARRANGEMENT OF WHICH SHOULD HAVE BEEN PLANNED FOR PLAY AND RECREATION FOR CHILDREN

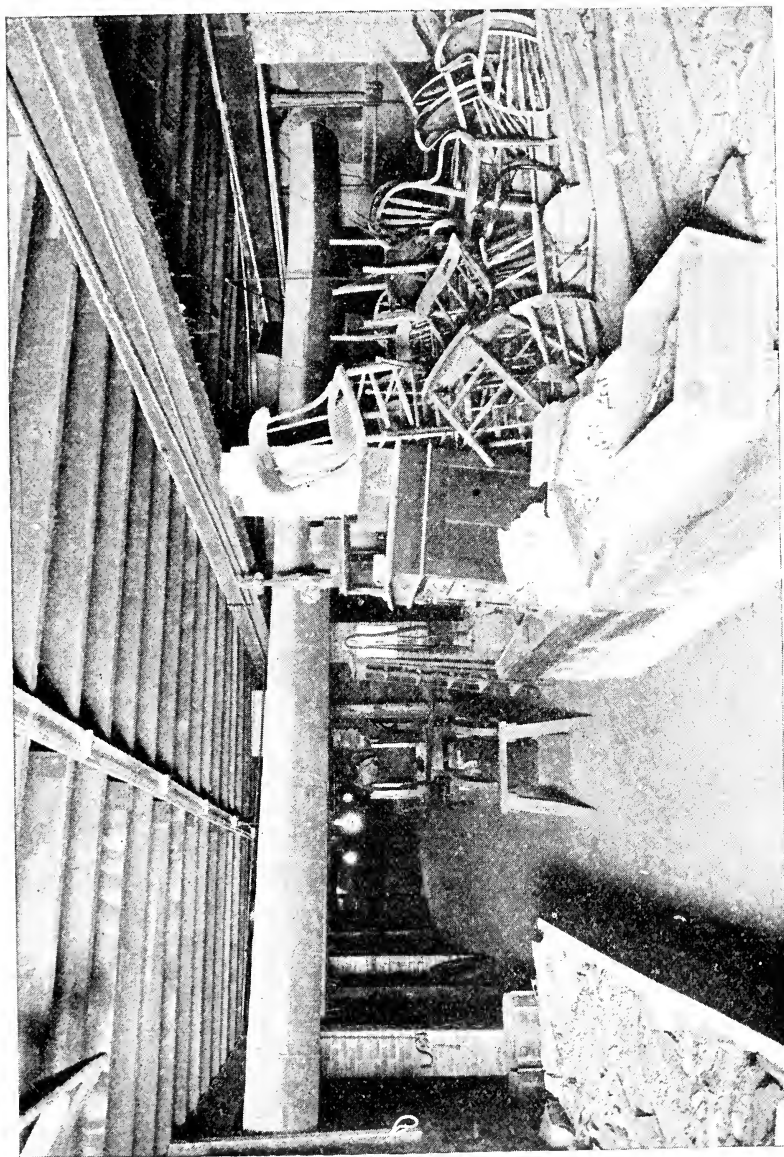
ILLUSTRATION 45. THE BASEMENT OF THE FIRST CONGREGATIONAL CHURCH. NOTE THE DEFECTIVE WIRING, JOINTS UNPROTECTED FROM THE DUCTS AND HEATERS, ONE OF THE FIVE HEATERS LOCATED IN THIS CONGESTED BASEMENT IS SEEN AT THE RIGHT

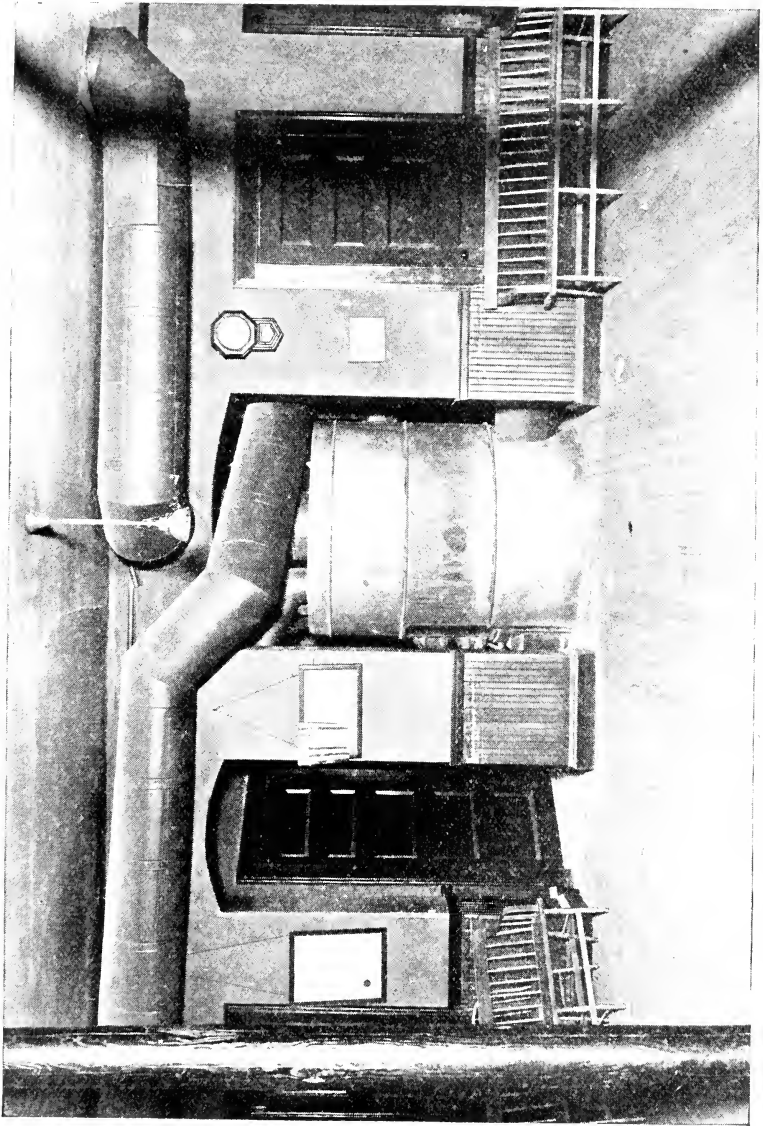
ILLUSTRATION 50. ONE OF THE UNPROTECTED FURNACES OF THE MYSTIC SIDE CONGREGATIONAL CHURCH FURNISHING A CONSTANT POSSIBILITY OF FIRE DANGER. THIS CONSTRUCTION SHOULD NEVER HAVE BEEN PERMITTED BY LAW

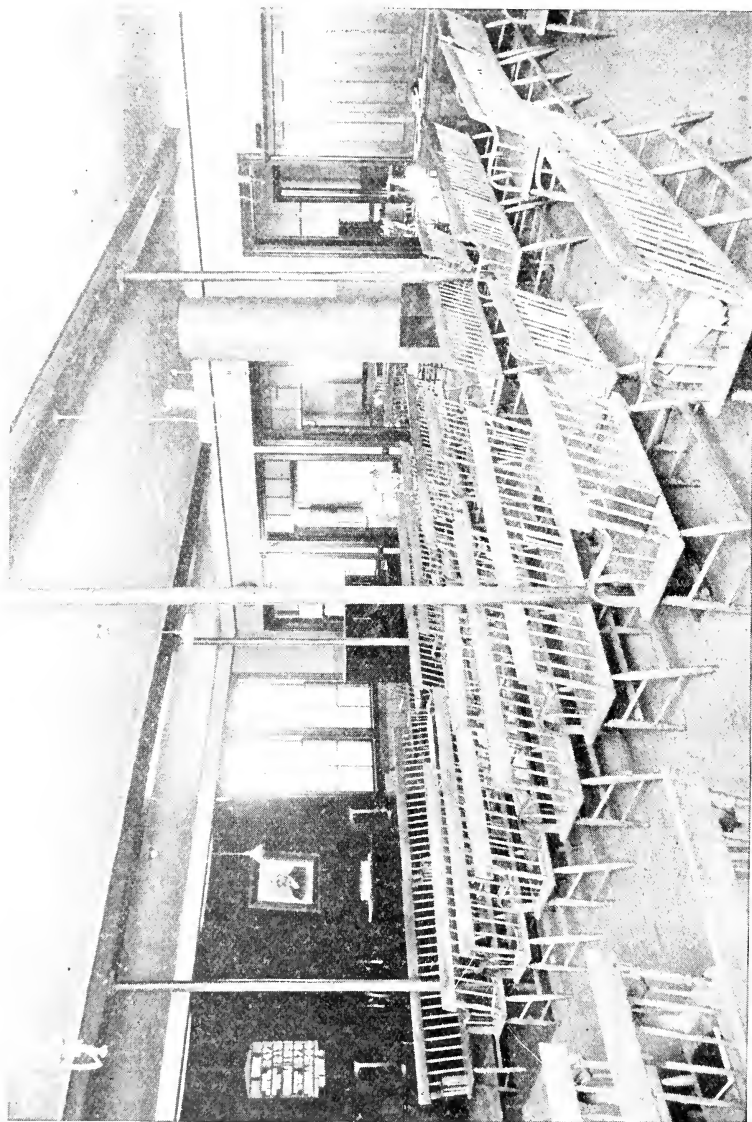
ILLUSTRATION 51. SHOWING THE SUNDAY SCHOOL ROOMS OF THE MAPLEWOOD METHODIST CHURCH. NOTE THE FLUE METHOD OF HEATING AT THE RIGHT CENTRE; THE INADEQUATE ARTIFICIAL LIGHTING AND THE UNDESIRABLE FURNITURE

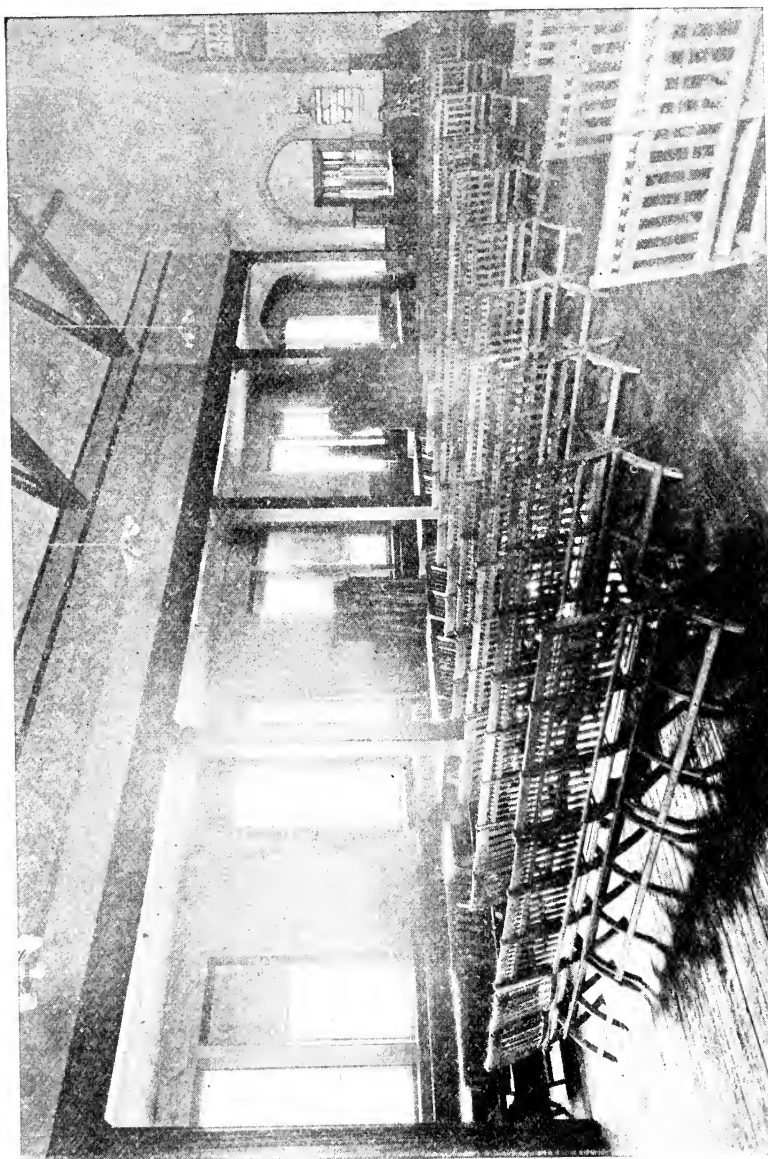
ILLUSTRATION 56. TEMPORARY SUNDAY SCHOOL ASSEMBLY ROOM OF ST. PAUL'S EPISCOPAL CHURCH. CURTAINS ON WIRES PROVIDE CLASSROOMS ABOUT EDGE OF ROOM. BAD CONDITION OF FLOOR, POOR KIND OF ARTIFICIAL LIGHTING AND INADEQUATE NATURAL LIGHTING SHOWN

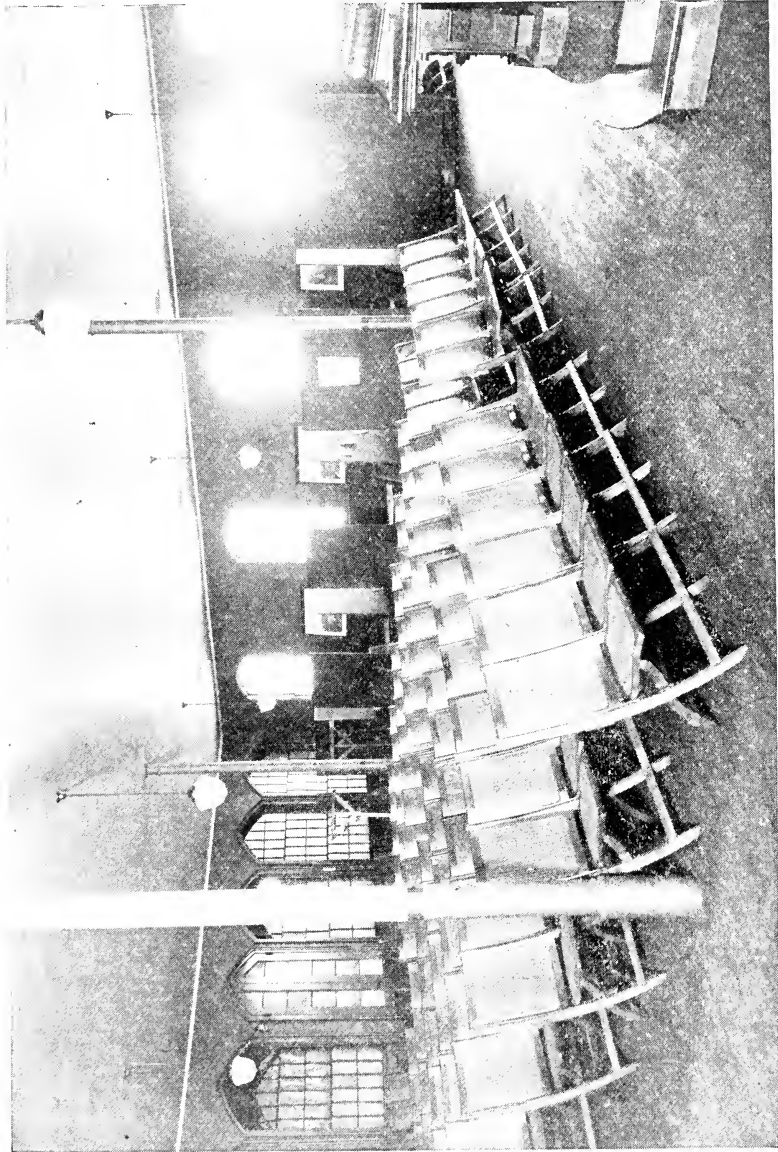
ILLUSTRATION 57. SUNDAY SCHOOL ASSEMBLY ROOM, FIRST CONGREGATIONAL CHURCH SHOWING THE MAKESHIFT SCREENED CLASS ROOMS AT SIDE OF ROOM NOTE THE SPLENDID TYPE OF ELECTRIC FIXTURES USED

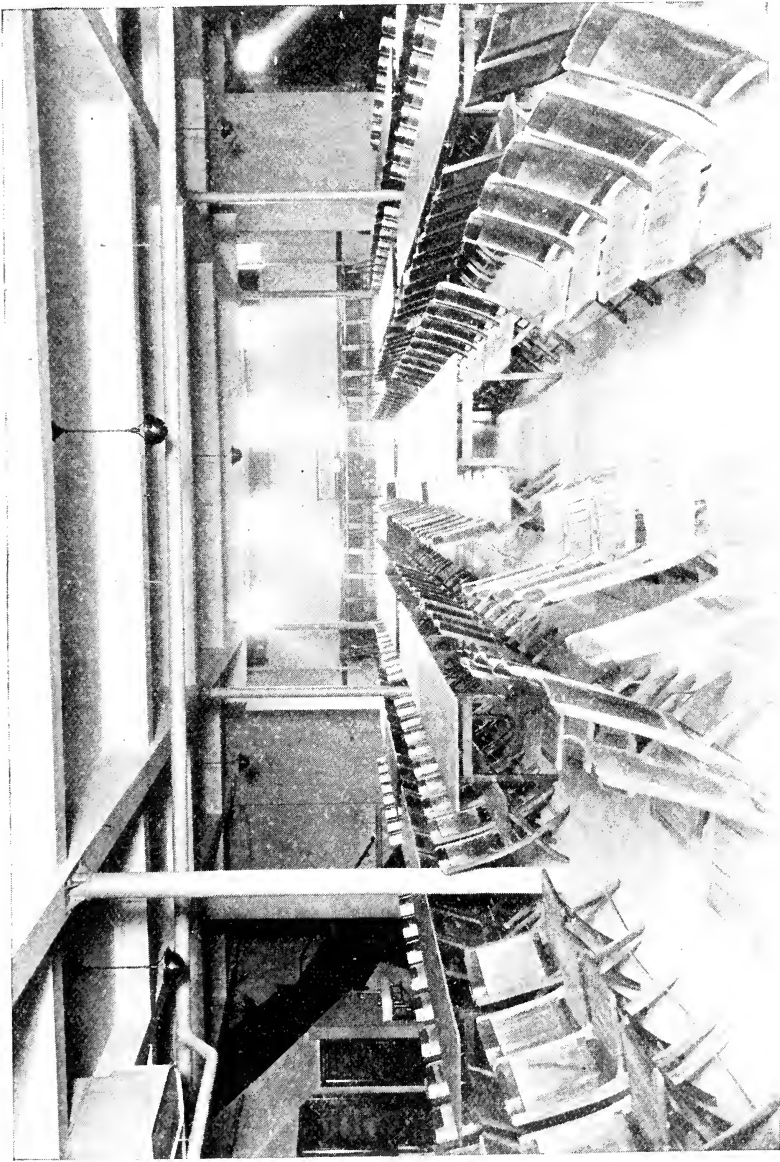
ILLUSTRATION 58 THE WELL-APPOINTED BANQUET ROOM IN THE BASEMENT OF THE FIRST BAPTIST CHURCH. SPLENDID INDIRECT ARTIFICIAL LIGHTING BUT INADEQUATE NATURAL LIGHTING

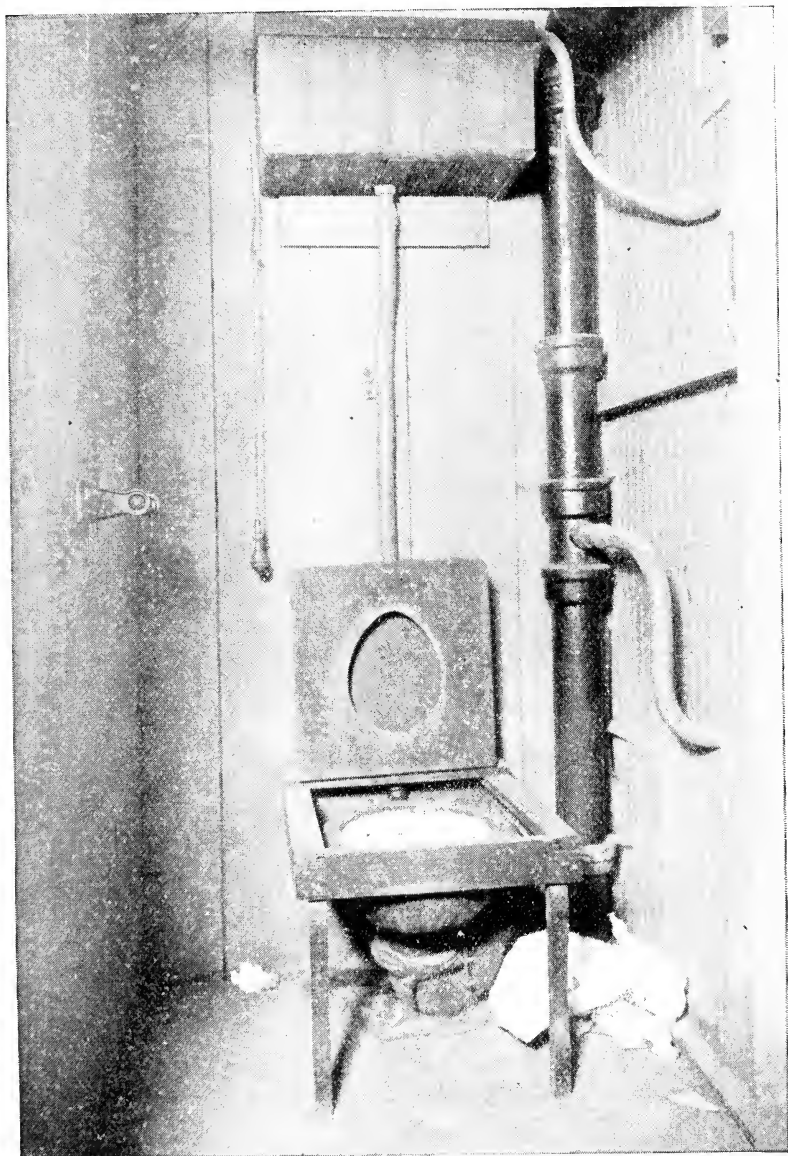
ILLUSTRATION 60. THE EXTREMELY UNSANITARY TOILET PROVISIONS OF THE ST. LUKE'S EPISCOPAL CHURCH

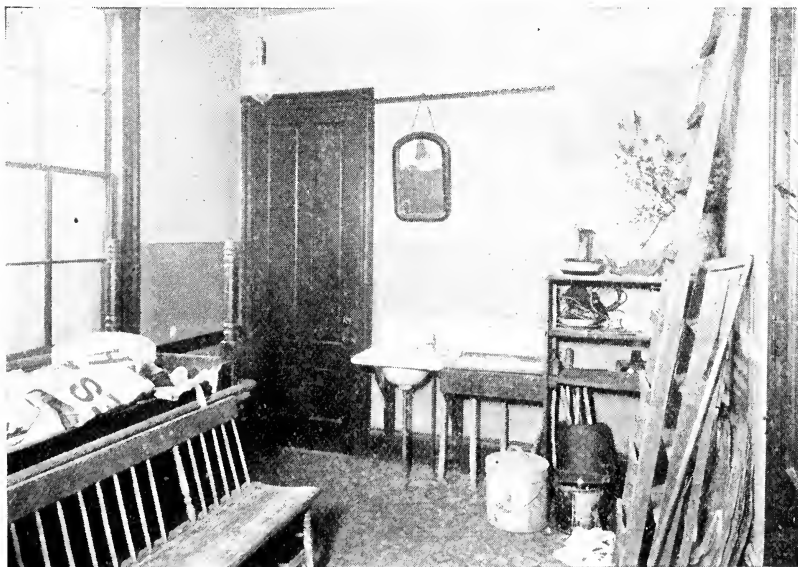
ILLUSTRATION 61. UNATTRACTIVE, POORLY-EQUIPPED KITCHEN OF THE MAPLEWOOD METHODIST CHURCH

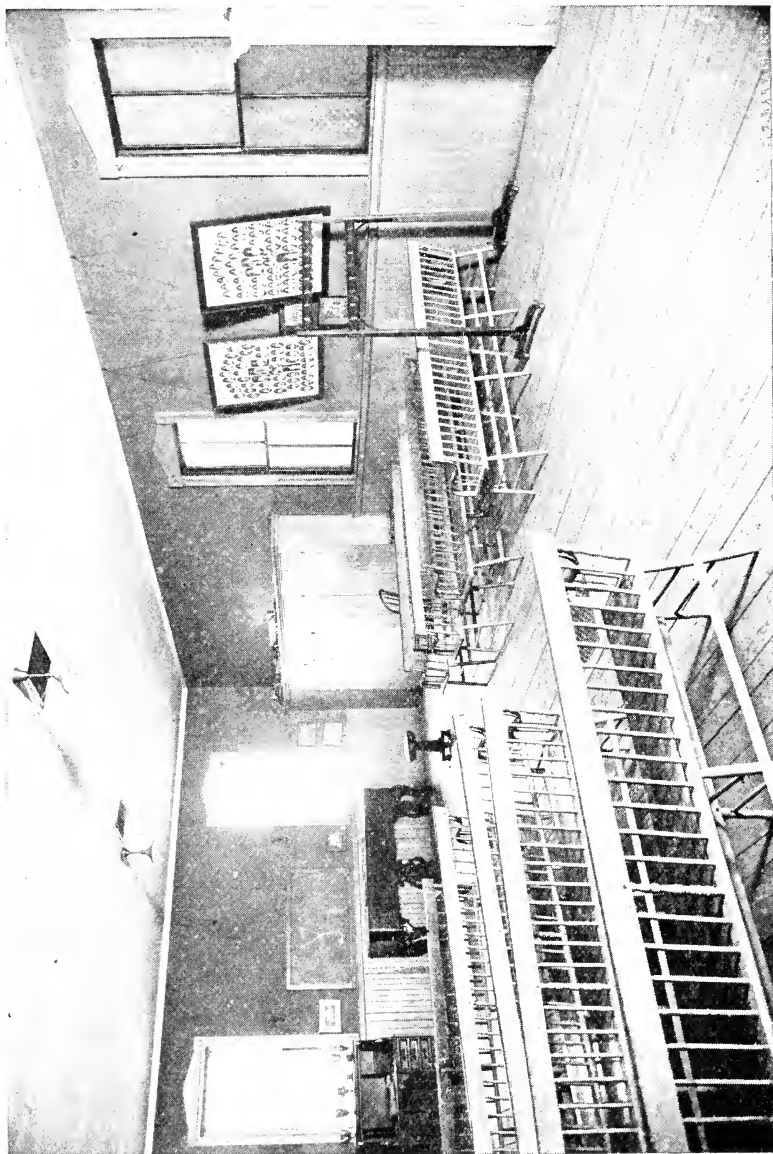
ILLUSTRATION 66. CHOIR ROOM IN THE TEMPORARY PART OF ST. PAUL'S EPISCOPAL CHURCH. ROOM IS LARGE ENOUGH BUT EQUIPMENT IS VERY POOR, AND NO ATTEMPT TO MAKE ROOM ATTRACTIVE

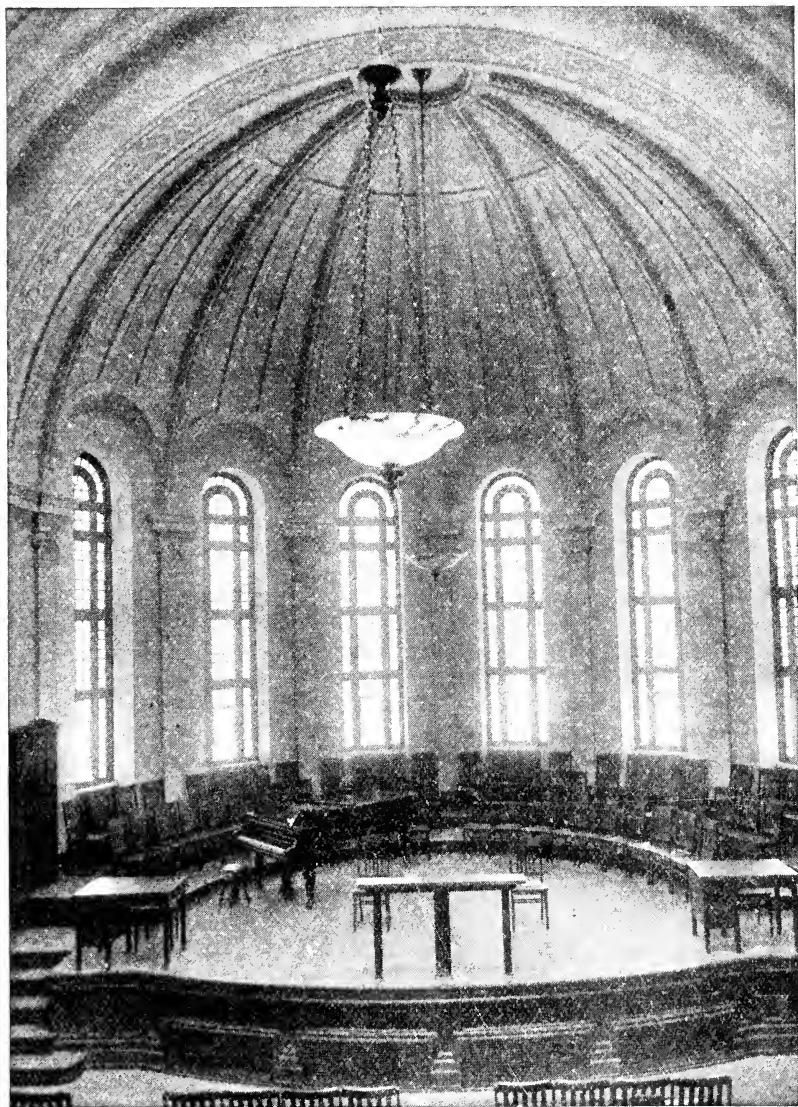
ILLUSTRATION 68. A SUNDAY SCHOOL ASSEMBLY ROOM IN THE FIRST BAPTIST CHURCH. WELL EQUIPPED PLATFORM, AND ATTRACTIVE ROOM, BUT AN ANNOYING SERIES OF CROSS LIGHTS FOR AUDIENCE TO FACE

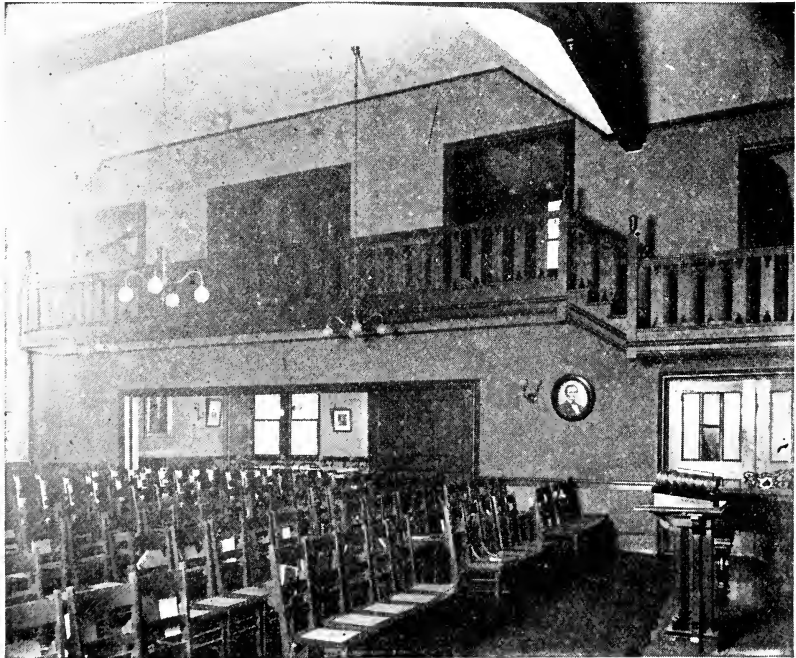
ILLUSTRATION 69. SUNDAY SCHOOL ASSEMBLY ROOM OF THE FIRST PARISH IN MALDEN, UNIVERSALIST. A WELL FURNISHED, IMPROPERLY LIGHTED ROOM, SHOWING BALCONY CONNECTION TO INADEQUATE CLASS ROOMS

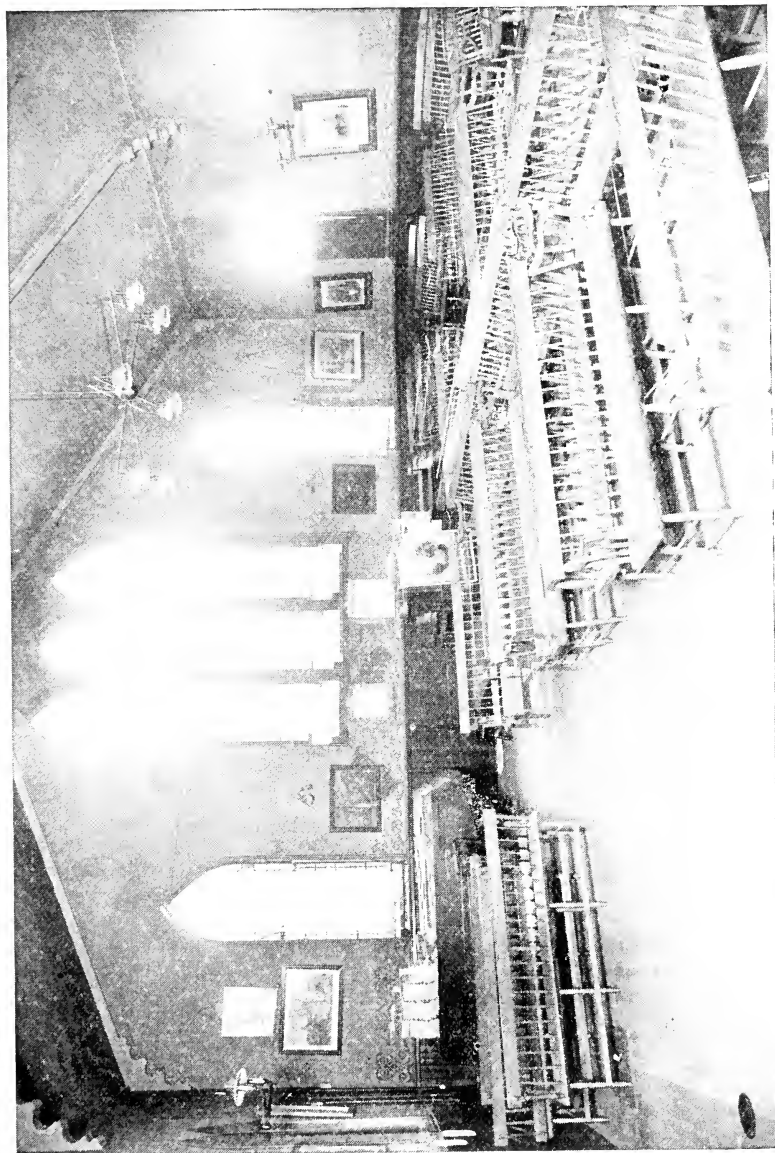
ILLUSTRATION 71. SUNDAY SCHOOL ASSEMBLY ROOM OF MAPLEWOOD BAPTIST CHURCH. NOTE STRONG LIGHT TO BE FACED, POOR ARTIFICIAL LIGHTING, AND BENCHES ARRANGED FOR SEATING A DOZEN OR MORE CLASSES IN THE SAME ROOM

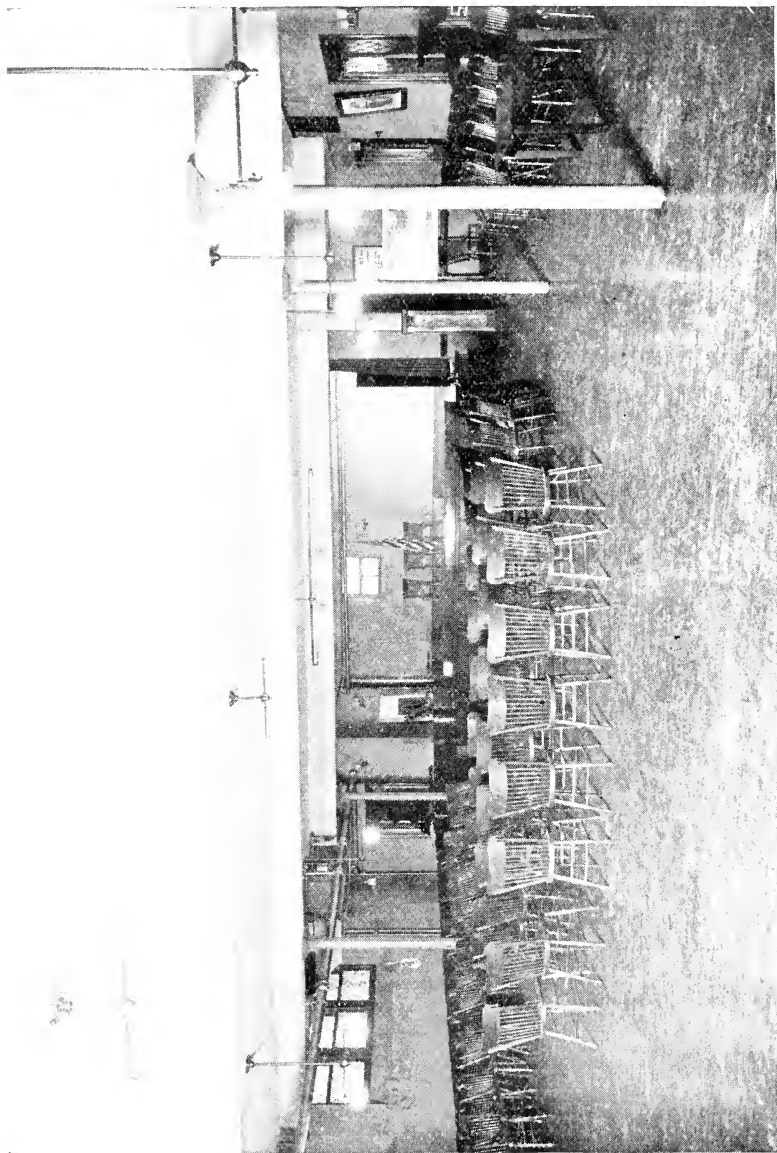
ILLUSTRATION 73. COMMUNITY ROOM OF FIRST PARISH IN MALDEN, UNIVERSALIST CHURCH. A BASEMENT ROOM WITH INSUFFICIENT NATURAL LIGHT. HAS PLATFORM STAGE WHICH CAN BE USED FOR SCHOOL AND COMMUNITY ENTERTAINMENTS

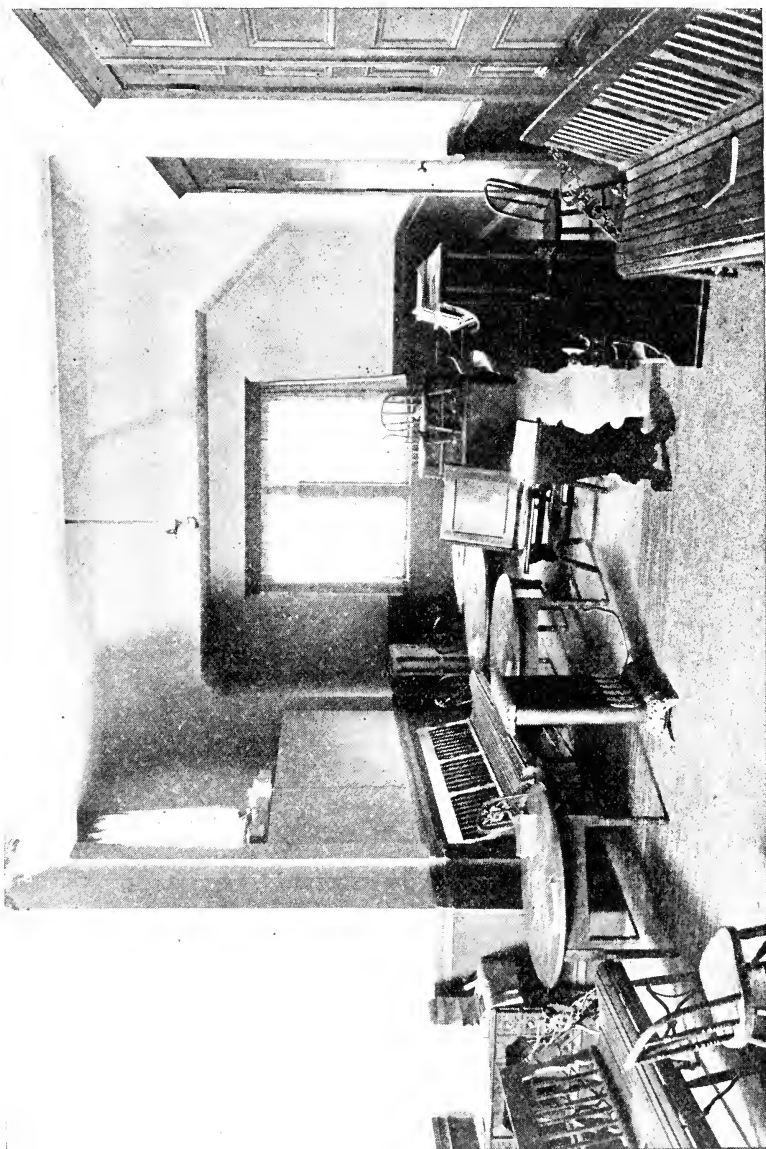
ILLUSTRATION 75. PRIMARY CLASS ROOM, FALCONER METHODIST CHURCH. IRREGULAR AND INADEQUATE FURNITURE, INCONVENIENT ARRANGEMENT, GAS HEATER, AND GAS LAMPS

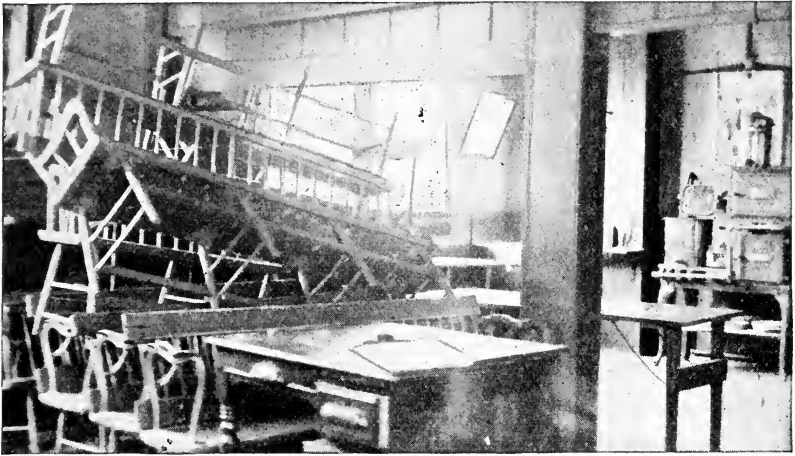
ILLUSTRATION 79. KITCHEN AND CLASS ROOM OF MAPLEWOOD BAPTIST CHURCH USED AS A STORE ROOM BECAUSE OF FAILURE TO PROVIDE SUCH SPACE IN ORIGINAL PLANS

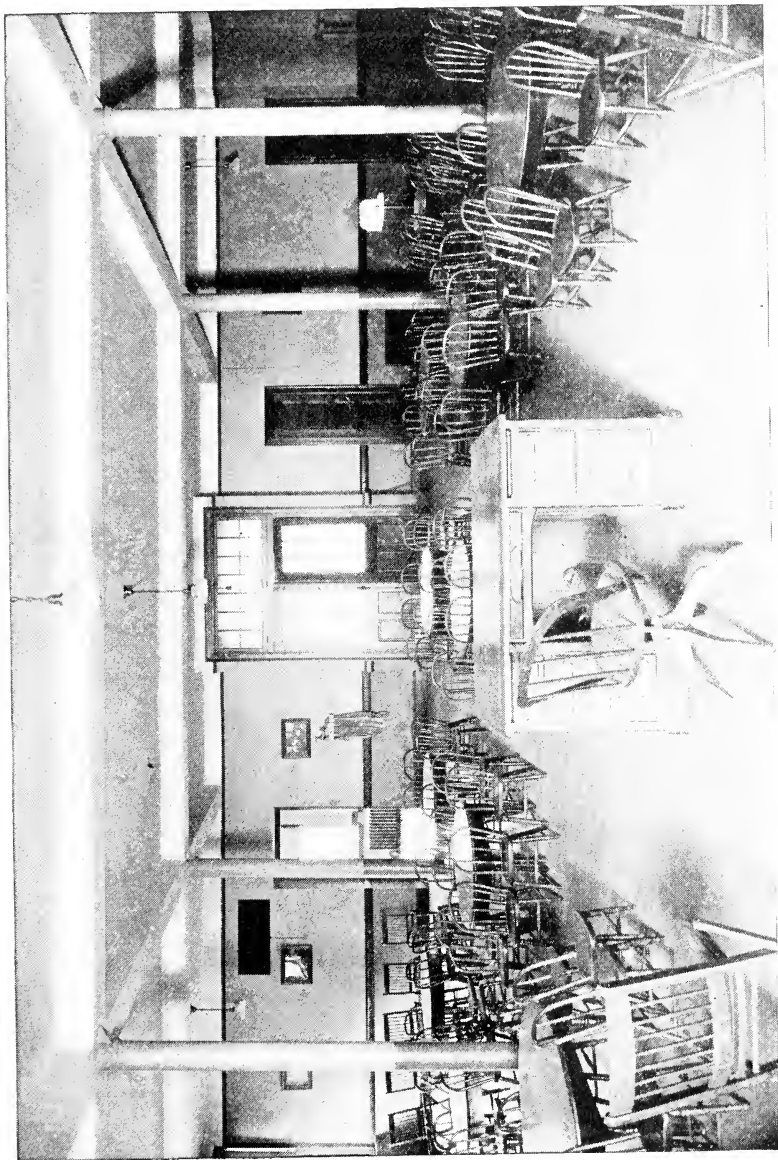
ILLUSTRATION 80. CLASS ROOM, FIRST BAPTIST CHURCH. WELL EQUIPPED, ATTRACTIVE CLASS ROOM, BUT WITH INADEQUATE NATURAL LIGHT DUE TO BLANK WALL ON ONE SIDE OF BUILDING
